Jug Mountain Ranch Resort Appendix 1: Photo Log Inspection Date: 7/21/2011

ID-002802-9 Inspection Date: 7/21/2011 TRIM Record: 2011AGF2111 Page **2** of **16**

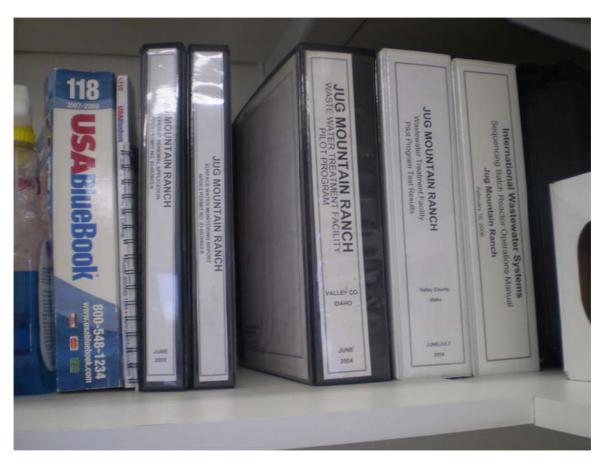
Figure 3. Operational manuals for the system and other reports and records.

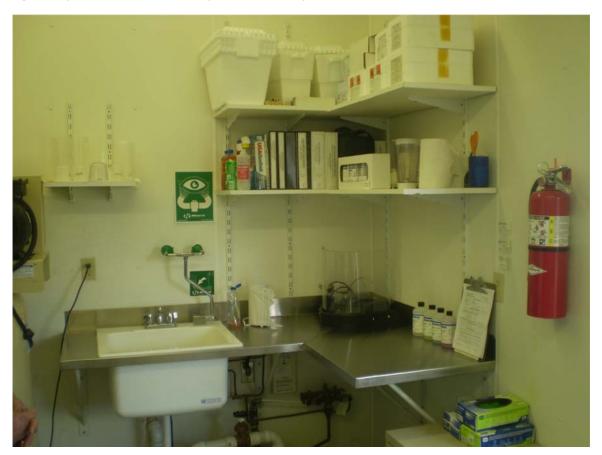
Figure 4. Onsite laboratory facilities.

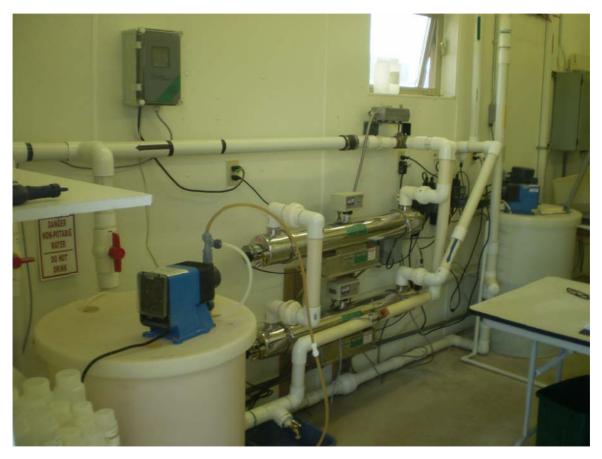
Figure 5. Coagulant addition (far right), UV disinfection system (center), methanol addition (left).

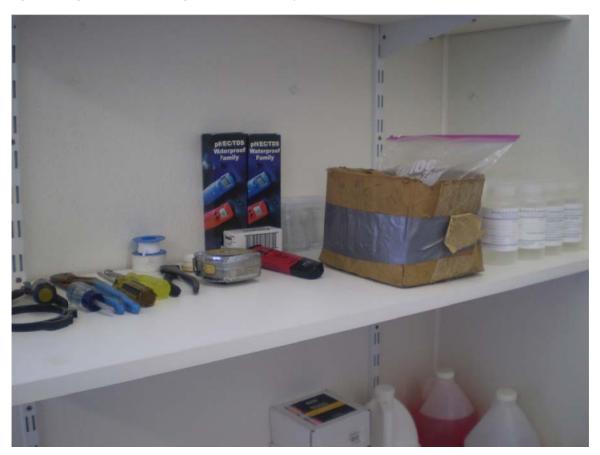
Figure 6. Equipment and analytical sample container storage.

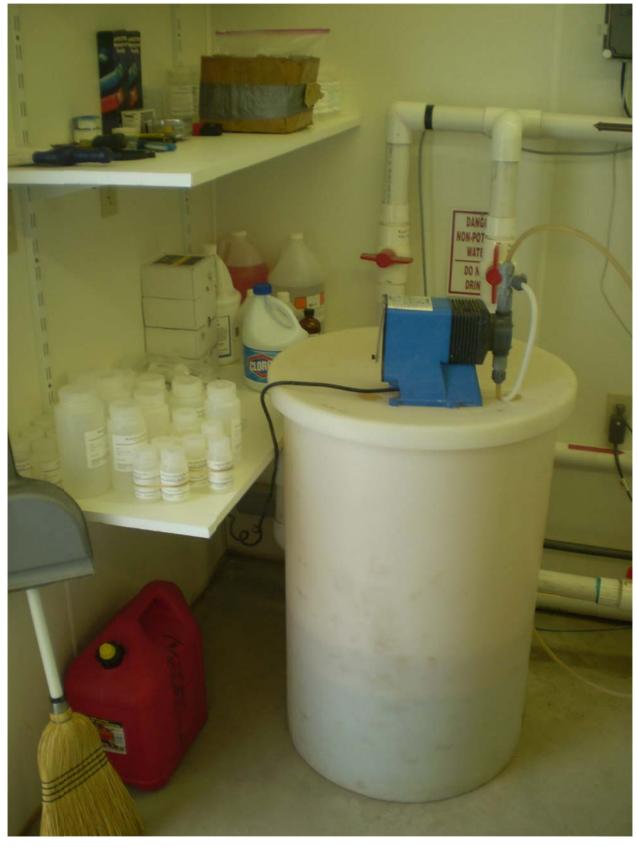
Figure 7 Methanol addition with analytical sample container storage on shelves to left.

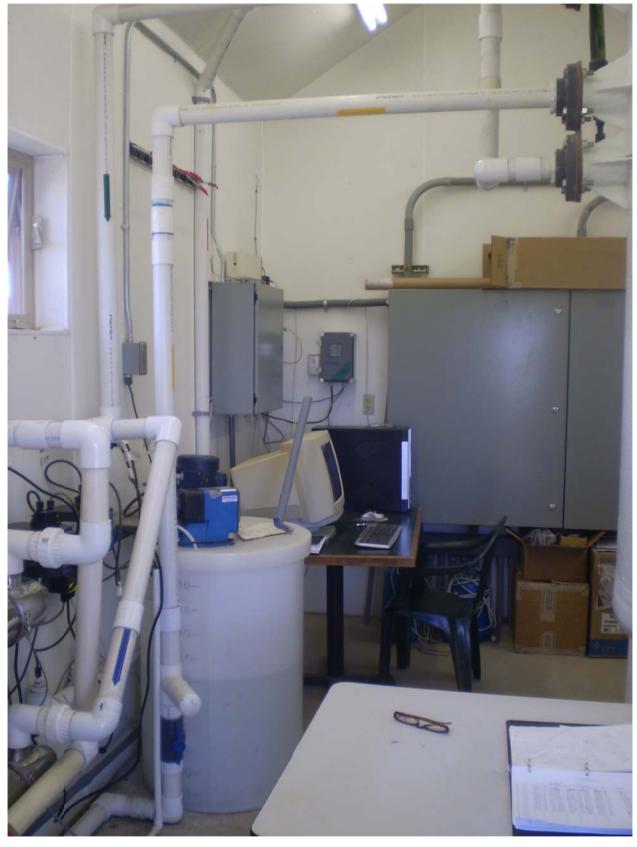
Figure 8. Coagulant addition with plant control terminal behind.

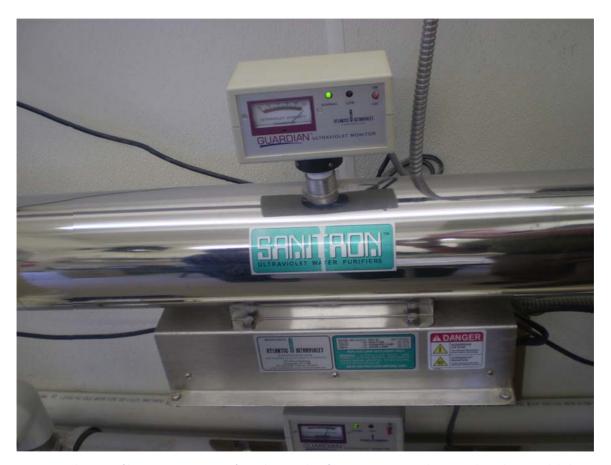
Figure 10. Close-up of lamp intensity gauge for in-line UV disinfection system. Top lamp is relatively new while bottom one shows lessening of intensity due to fouling. Operator has replacement lamps on hand.

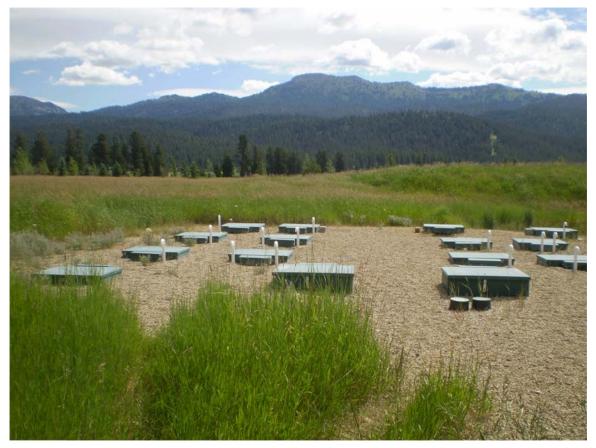
Figure 11. Access hatches for both SBRs.

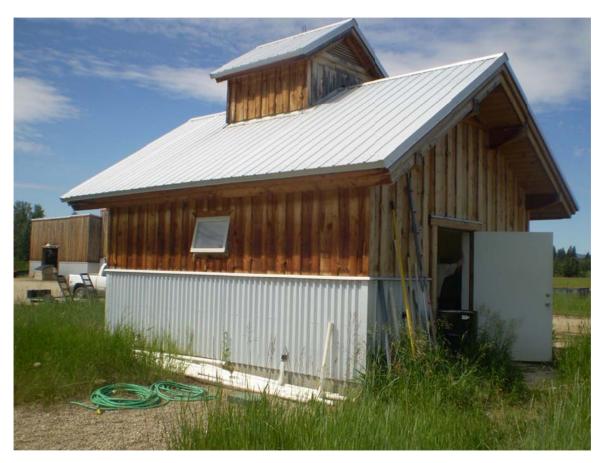
Figure 12. Exterior of operational building.

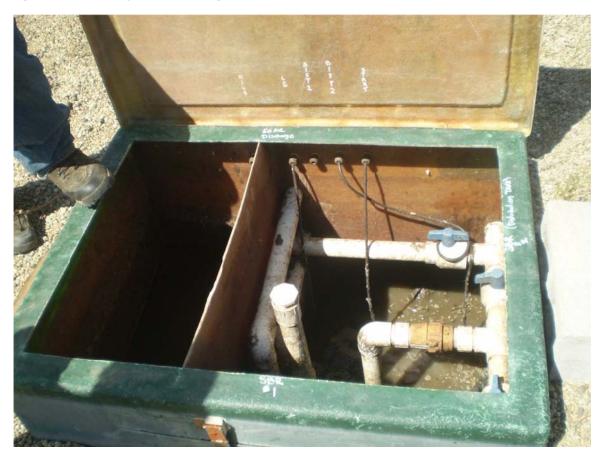
Figure 13. SBR splitter box. Influent sampling point.

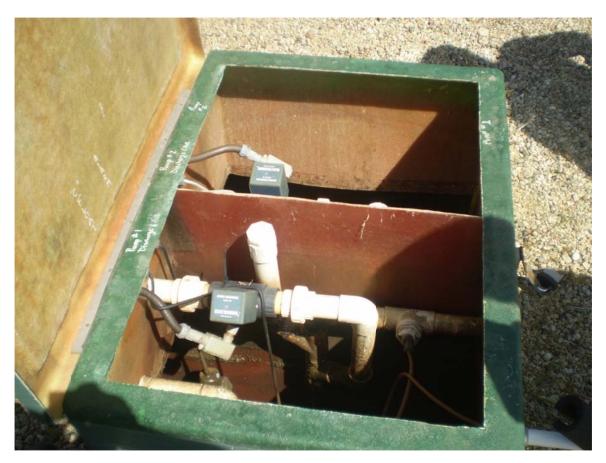
Figure 14. Activated sludge pumps for reacting stage of treatment.

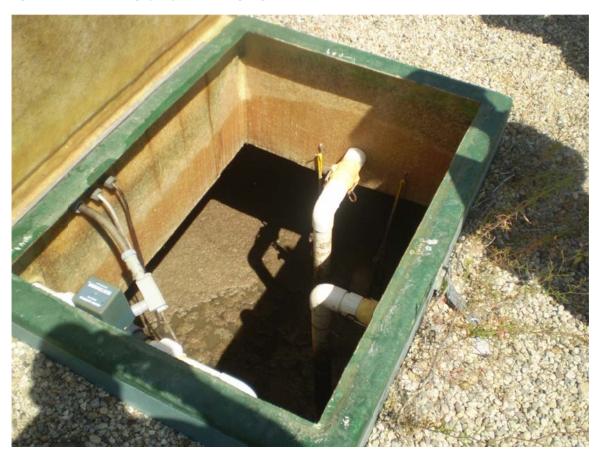
Figure 15. Settling stage of treatment.

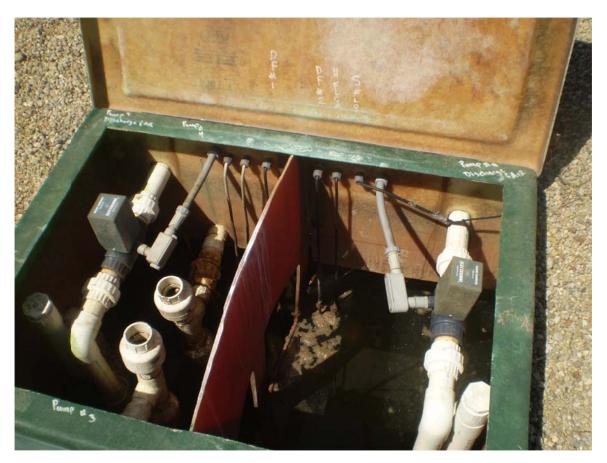
Figure 16. Decanting phase valves.

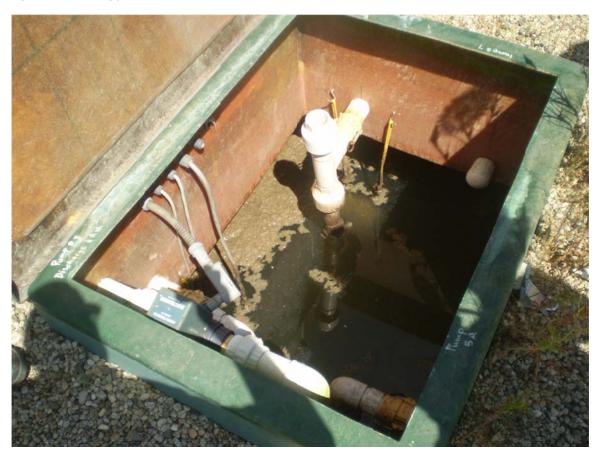
Figure 17. Plant effluent sampling point prior to disinfection.

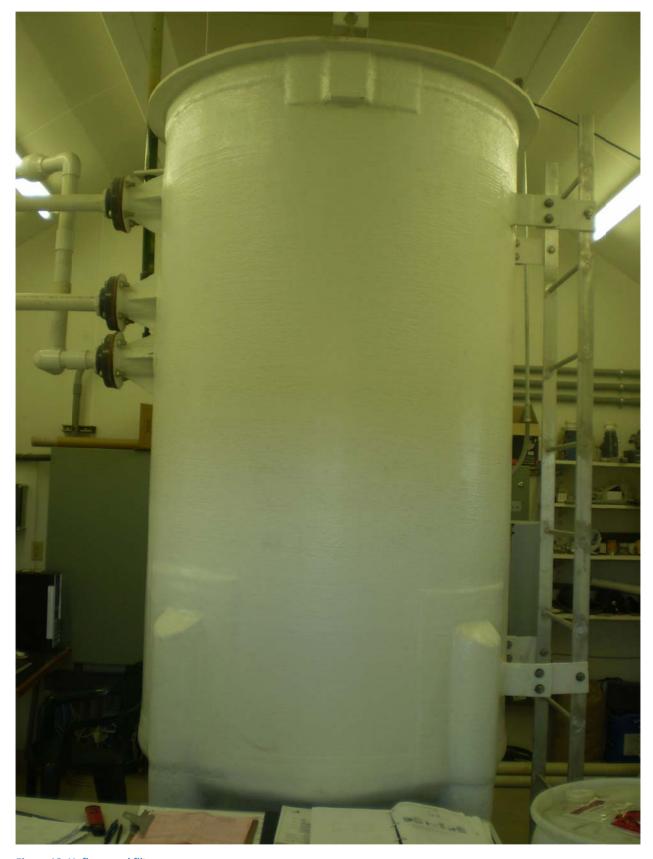
Figure 18. Upflow sand filter.

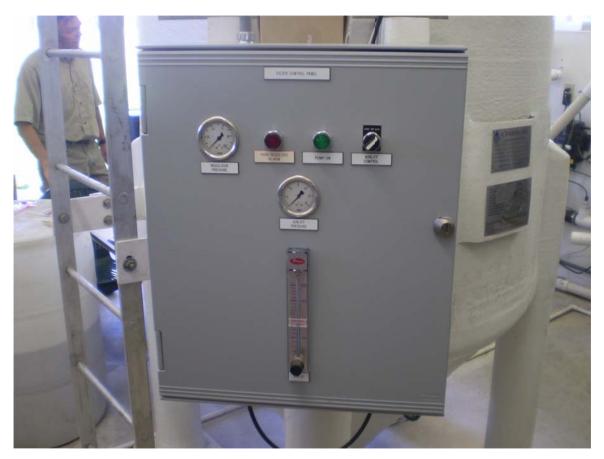
Figure 20. Sand filter control panel.

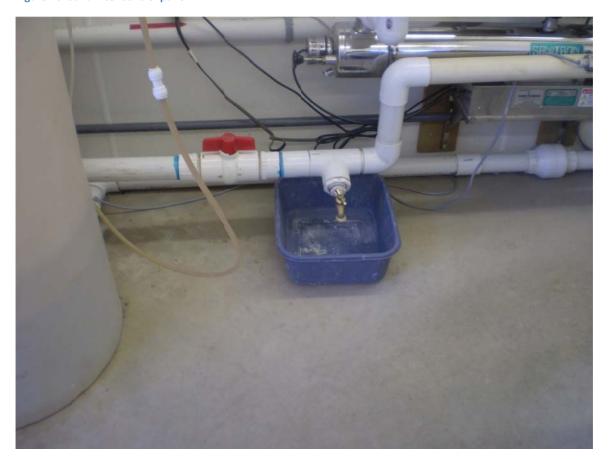
Figure 21. Sampling point for bacteriological samples (located after UV disinfection).

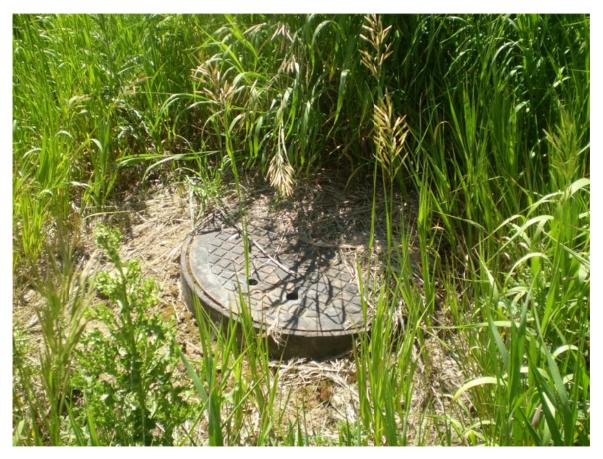
Figure 22. Manhole cover for effluent from treatment plant.

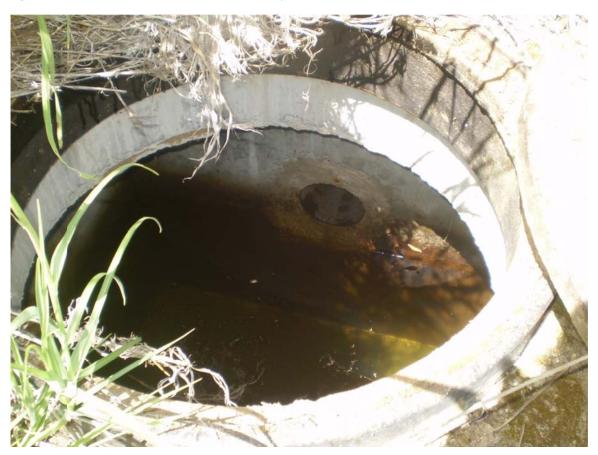
Figure 23. Interior of effluent manhole showing discharge pipe from treatment plant.

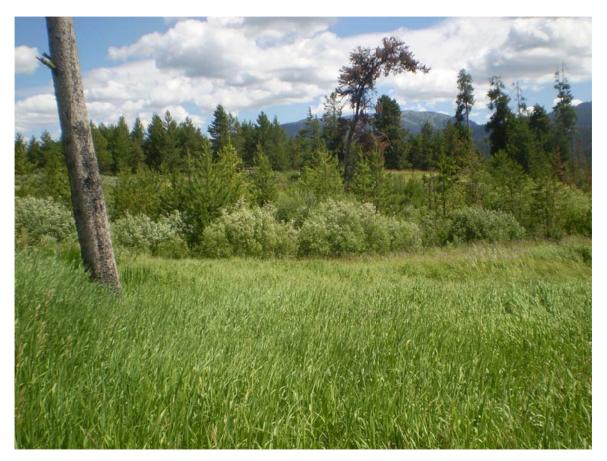
Figure 24. Discharge point is located in Cold Creek (area of high-density trees and bushes) approximately 100 feet from manhole. The upstream sample is taken approximately 200 feet upstream (to the left) of the discharge point.

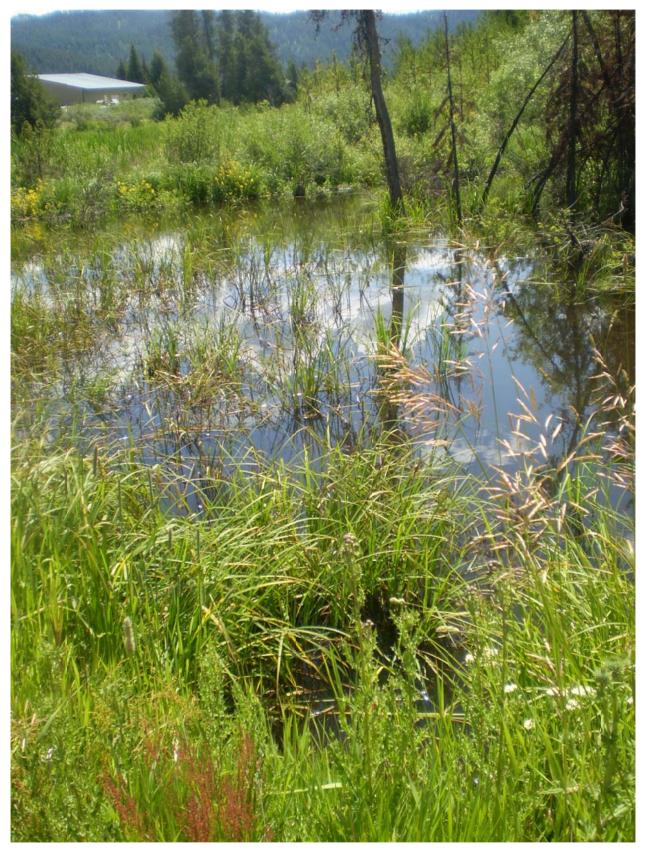
Figure 25. Discharge sampling point (inlet to Carey Pond). Vegetation at rear of photo is on a beaver dam which is periodically perforated by facility personnel.
